Manhole Inspection Summary

Manhole # S51I__006MH

Location Address: **rear of 2709 eastern ave**

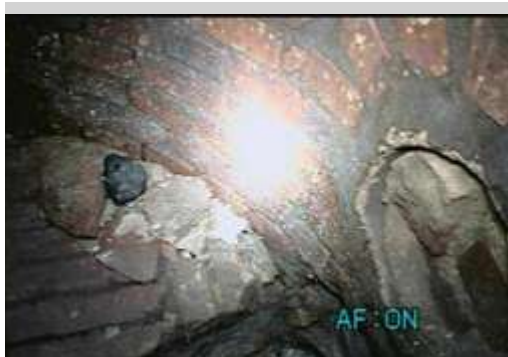
Defect 4

Condition: ☐ Sound ☒ **Cracked** ☐ Root Intrusion ☐ Deteriorated ☐ Leaks ☒ **Debris**

deteriorated bench

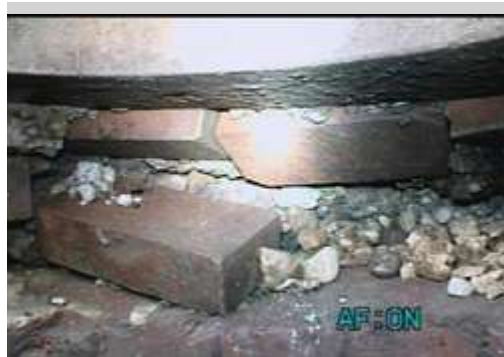
Defect 3

Condition: ☐ Sound ☐ Cracked ☐ Root Intrusion ☒ **Loose Brick** ☒ **Deteriorated**

Chimney deteriorated
frame adjustment

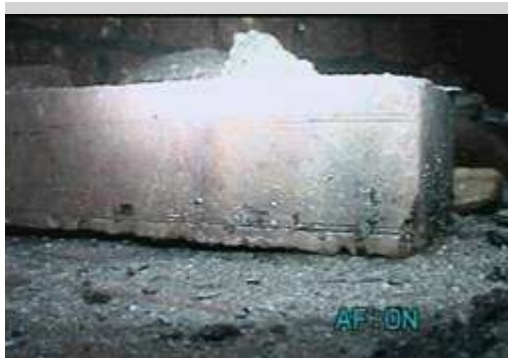
Defect 2

bench debris

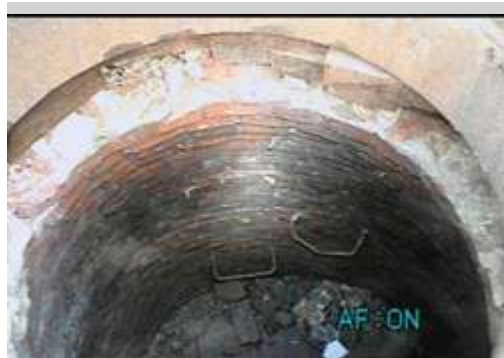
Defect 1

Steps Count: **4** Missing: **2** ☒ **Corroded**

steps

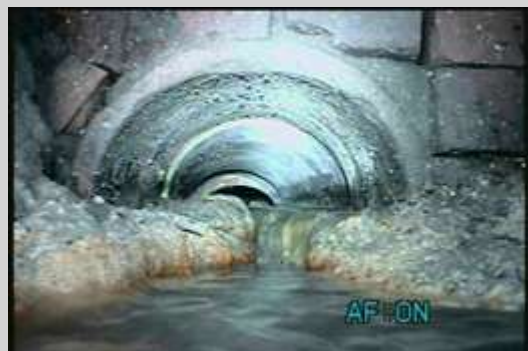
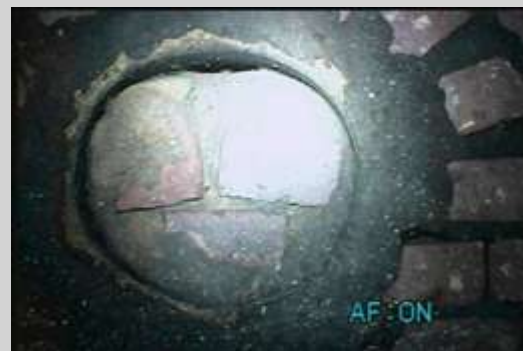
9 O'Clock Inflow

sealed

Deposits: ☐ None ☐ Mud ☒ Sludge ☐ Debris ☐ Grease

Silt Depth: 4 (in.) Deposits Extent: Medium

Drop Condition: Clogged
